Missouri Registry Annual Report

Registry of Confirmed Abandoned or Uncontrolled
Hazardous Waste Disposal Sites in Missouri

Fiscal Year 2022

**Missouri Department of Natural Resources
Division of Environmental Quality
Environmental Remediation Program**

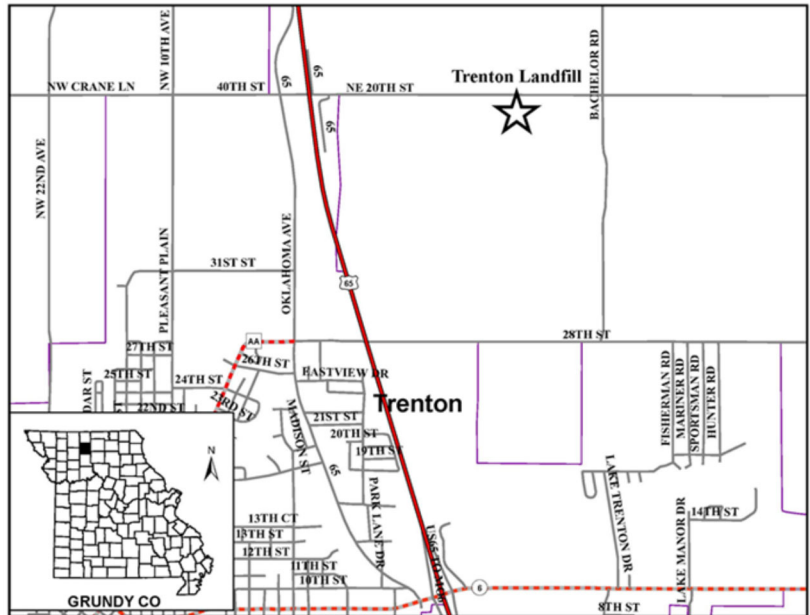
In 2015, the city completed the most recent repair work, including fixing areas where all-terrain vehicles had

damaged the landfill cap. To address the damaged areas, the city pushed existing berms over into the areas of subsidence, then spread and compacted the existing soil. The city added off-site soil to create a clay cap that was 3 feet thick, with enough top soil added to support good vegetation. Woody vegetation was removed, but trees on the western edge were left intact to protect the stream bank and to uptake subsurface leachate. The site was graded, seeded, and mowed.

On April 20, 2022, the Department conducted the Fiscal Year 2022 annual site inspection, during which inspectors observed evidence of recent repairs for ponding and erosion. The repaired areas will need seeding in order to prevent future erosion. The city of Trenton is addressing erosion issues as they appear.
